Wagner Creek Greenway Connection Plan

May 2007

WAGNER CREEK GREENWAY CONNECTION CONCEPTUAL PLAN

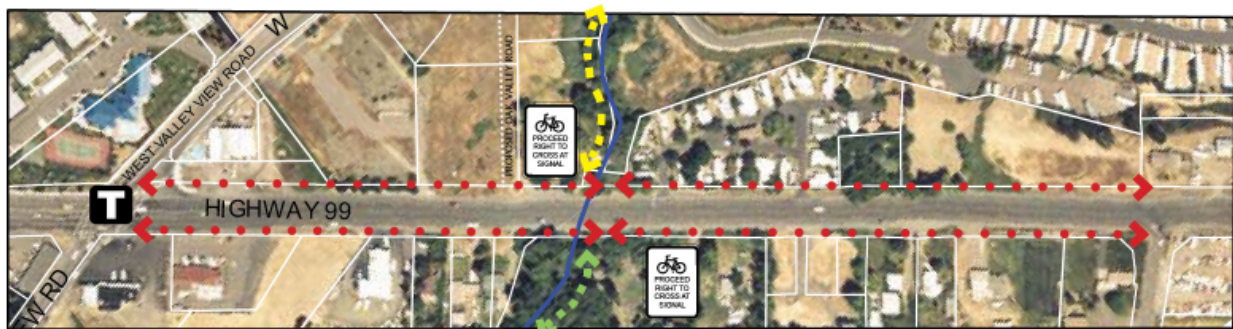
The following figure illustrates the concept of diverting Greenway users to a signal on Highway 99.

PLAN VIEW - USE EXISTING SIDEWALKS AND BIKE LANES TO SIGNALS
SHORT TERM RECOMMENDATION

Recommendation: Requiring cyclists to turn right and use the bike lane to access the signalized intersections is the **preferred interim alternative**. Although it is expected that enforcing com-

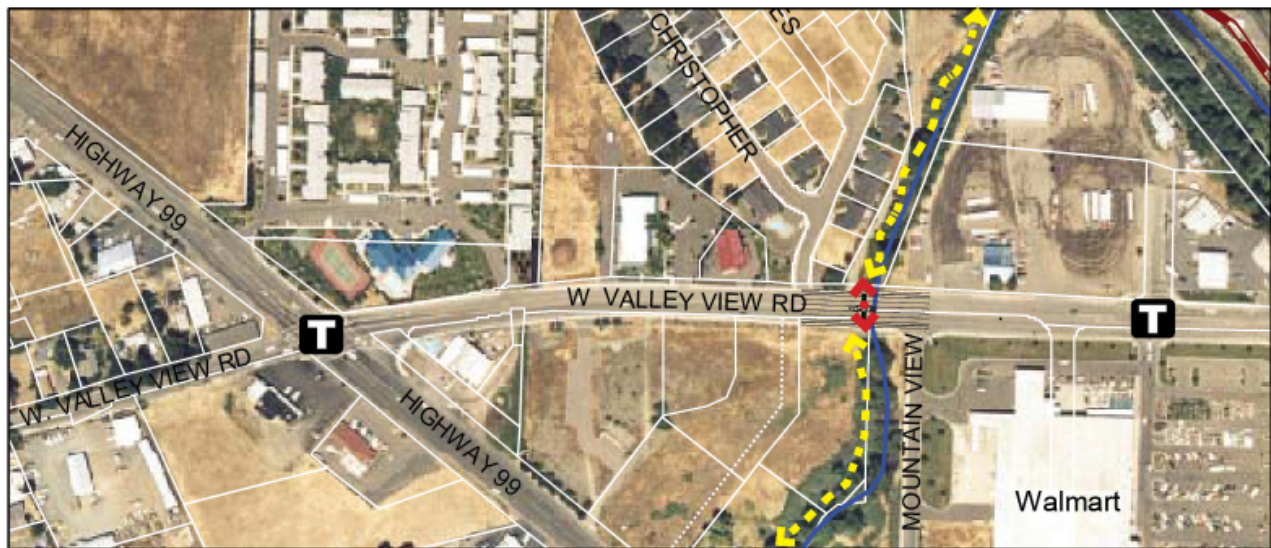
The figure below illustrates the locations and potential design of a mid-block crossing on West Valley View Road.

**PLAN VIEW - AT GRADE CROSSING
LONG TERM RECOMMENDATION**

Recommendation: Because of the traffic volumes and expected traffic gaps, a mid-block crossing with a center refuge island is a potential solution for the trail crossing of West Valley View. Since there appears to be sufficient width and length in the existing painted center lane in this location, a permanent center refuge and mid-block crossing is the **recommended as the long-term alternative** to crossing West Valley View.

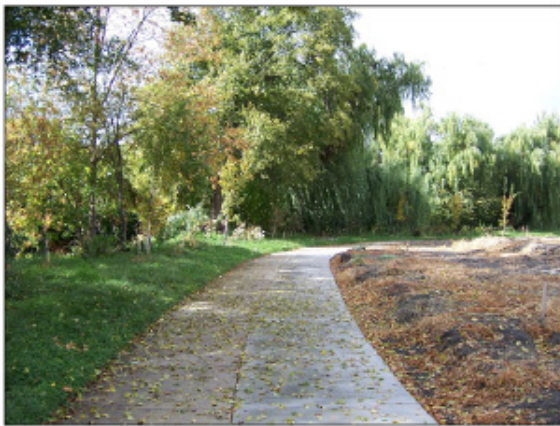
The existing section of the Wagner Creek Greenway trail is constructed of concrete. This is a good trail surface. It is less prone to buckling from tree roots or sub-grade subsidence, and the edges are less likely to crumble or allow plants to invade the surface. Concrete surfaces have a longer life span and require less frequent maintenance than other surfaces, such as asphalt.

CONCRETE TRAIL
(EXISTING SECTION OF WAGNER CREEK TRAIL)

Concrete or asphaltic concrete are the recommended surface materials for the Wagner Creek Greenway. Concrete is preferred for its low-maintenance characteristics and its ability to weather annual flood events. When properly cared for, concrete will last indefinitely. Asphalt is less expensive to pour but requires more upkeep.

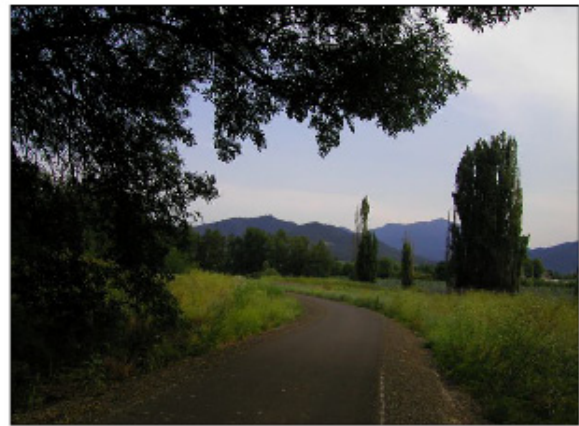
However, initial site preparation and materials costs are lower with asphalt. If properly maintained, asphalt is an appropriate surface for trails.

ASPHALT TRAIL
(EXISTING SECTION OF BEAR CREEK TRAIL)
